DESIGNING WITH PRECAST

BROOMFIELD COMMUNITY CENTER BROOMFIELD, COLO.

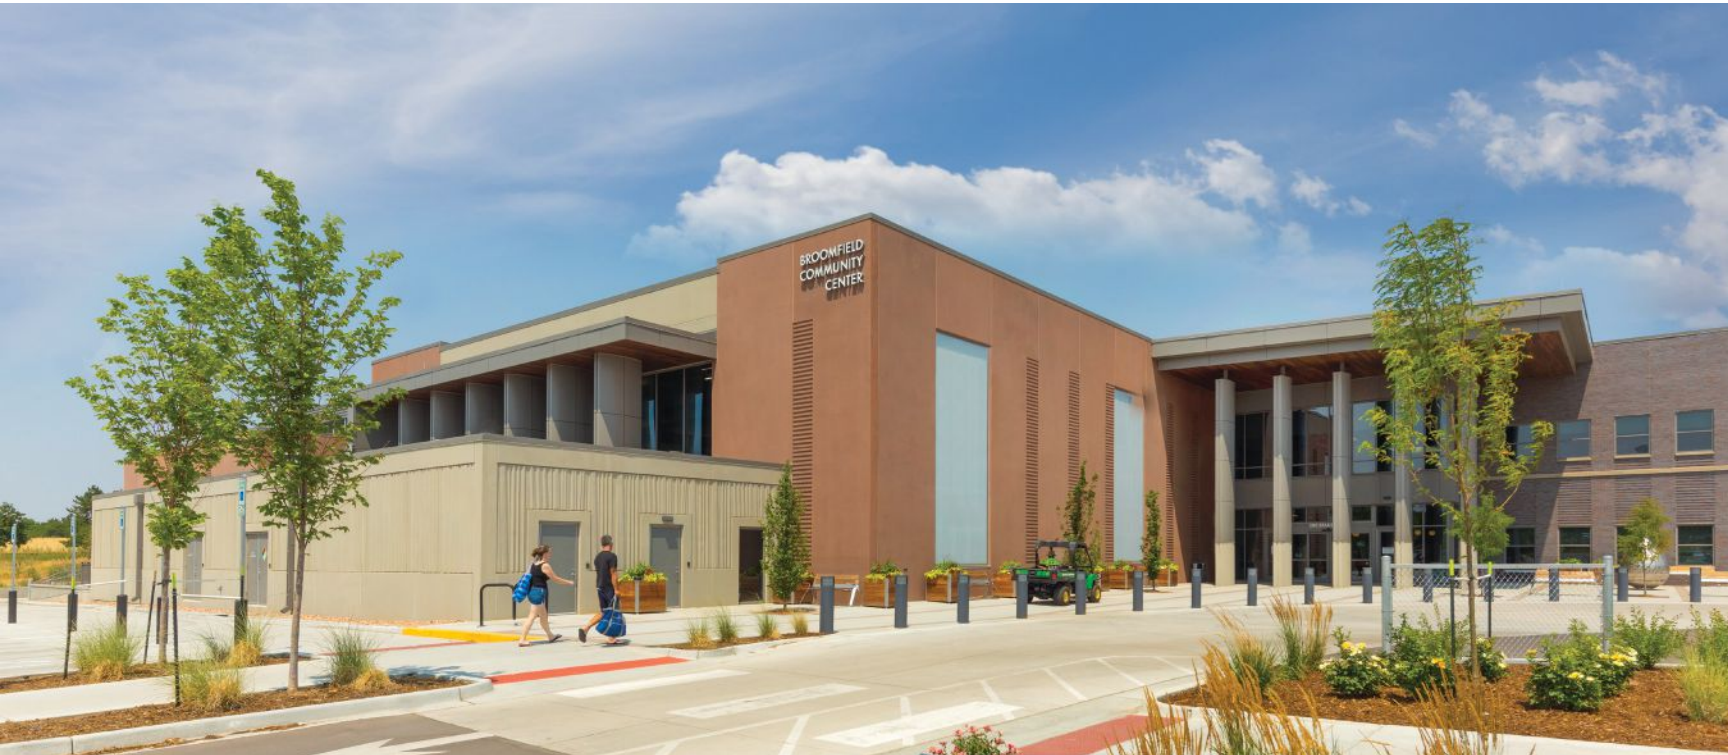
*The sawtooth detail on the exterior of the community center draws indirect sunlight into and through the pool area.
Photo: WELLS.*

The sawtooth detail on the north elevation draws indirect sunlight into and through the warm pool. A custom ribbed liner was used sparingly as an accent at the main entry and around the natatorium and picks up the masonry detailing on the adjacent senior center. "It was chosen for its playfulness and ability to change with the light," says Hanlon. The sawtooth detail in plan

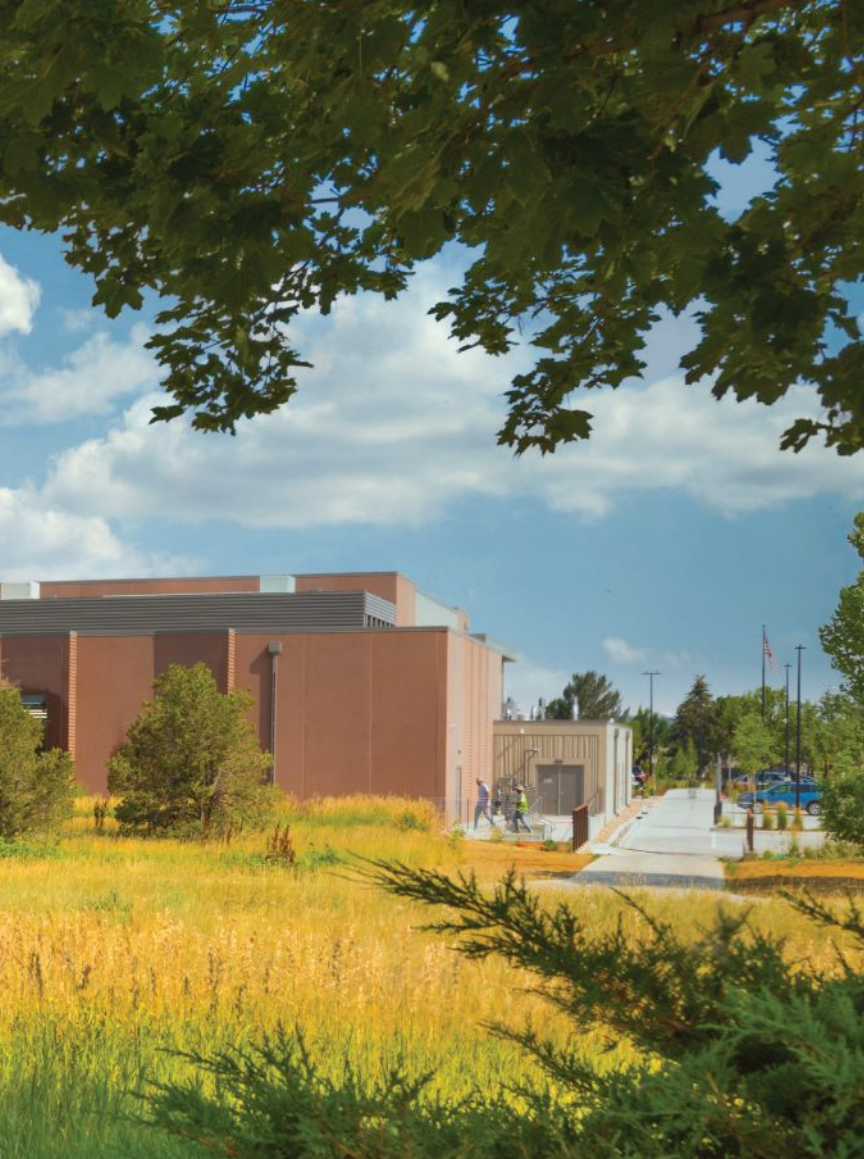
*On the north side of the site, the community center is only 10 ft away from protected wetlands. The project team took great care not to disturb any protected areas.
Photo: WELLS.*
